RESTORING Faith

A heritage icon

The 2010 damage and assessment work

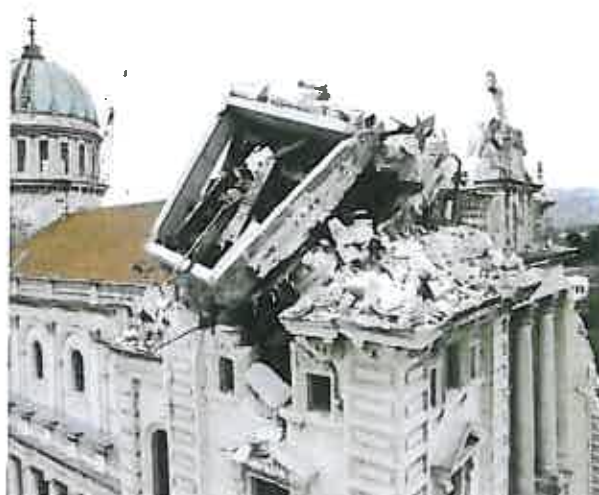
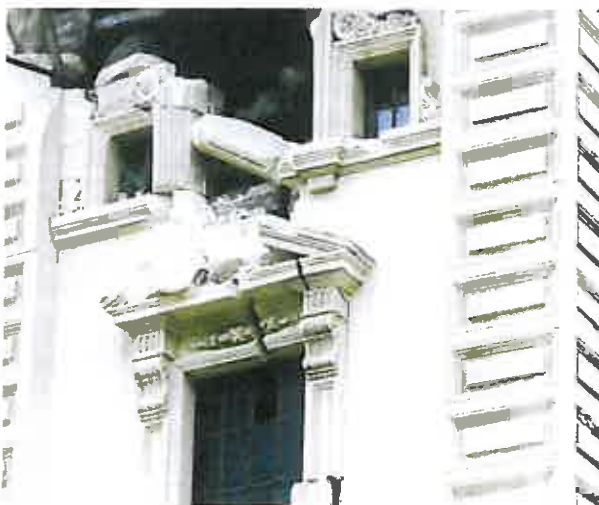
Some of the work to protect and to completely restore the basilica is already well under way. Image courtesy of Opus International Consultants

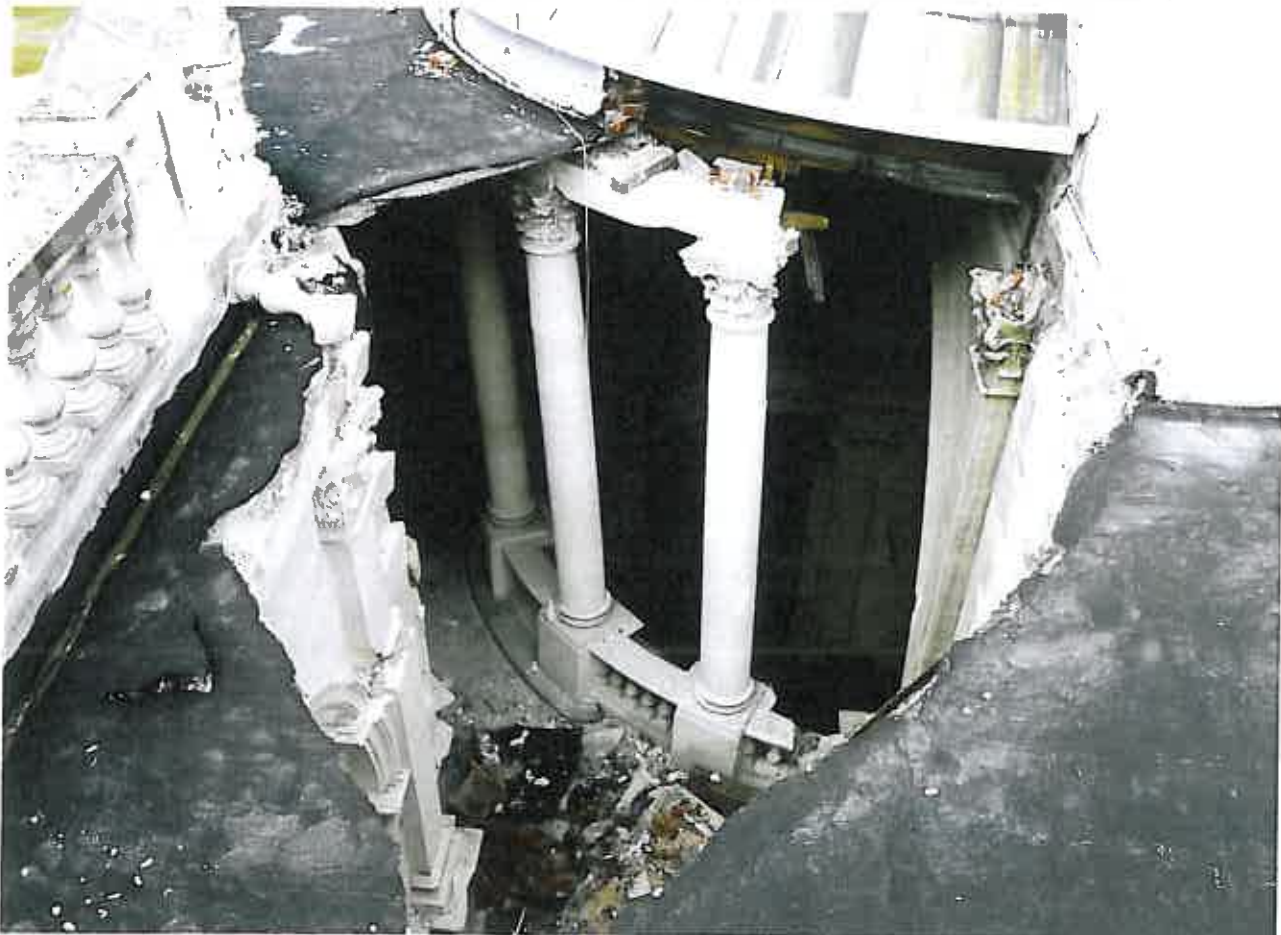
Looking through the collapsed roof into the interior of the cathedral beneath the main dome. Image courtesy of Opus International Consultants

The February event caused significant damage to the rear of the basilica sacristy area. This was related partly to the direction of the earthquake, and is also a result of the dome's heavy weight and height. The entire dome section weighs something around 300 tonnes, and is supported on large arches coming down onto four large columns. Shear failure of the dome structure has caused a large hole to open up in the drum of the dome on one side, and the first floor roof has partially collapsed.

"There seems to be something odd going on with the rafters in the dome because you can see the copper on the main dome has wrinkled," Mr Brown says. "There has obviously been some sort of twisting action, which has forced the dome to try to spiral down on itself. There are also cracks from where the dome meets the roof, tracking all the way down to the bottom rear corner of the building because of the weight and the ground motion. The whole rear section has cracked and moved."

The main focus now is to stabilise the rear of the basilica by removing the weight of the large dome, which is further weakening the back wall of the building with every aftershock. This will also remove the falling hazard the dome currently presents. In addition, the north tower needs to be secured either by removing damaged parts or by shoring it up.

"We're going to deconstruct the main dome using a 400-tonne crane – one of the largest in the country," Mr Lester says. "The plan is to first of all take the roof of the dome off, which is basically timber trusses with copper over the top. Then we're going to work our way down taking it off in pieces."

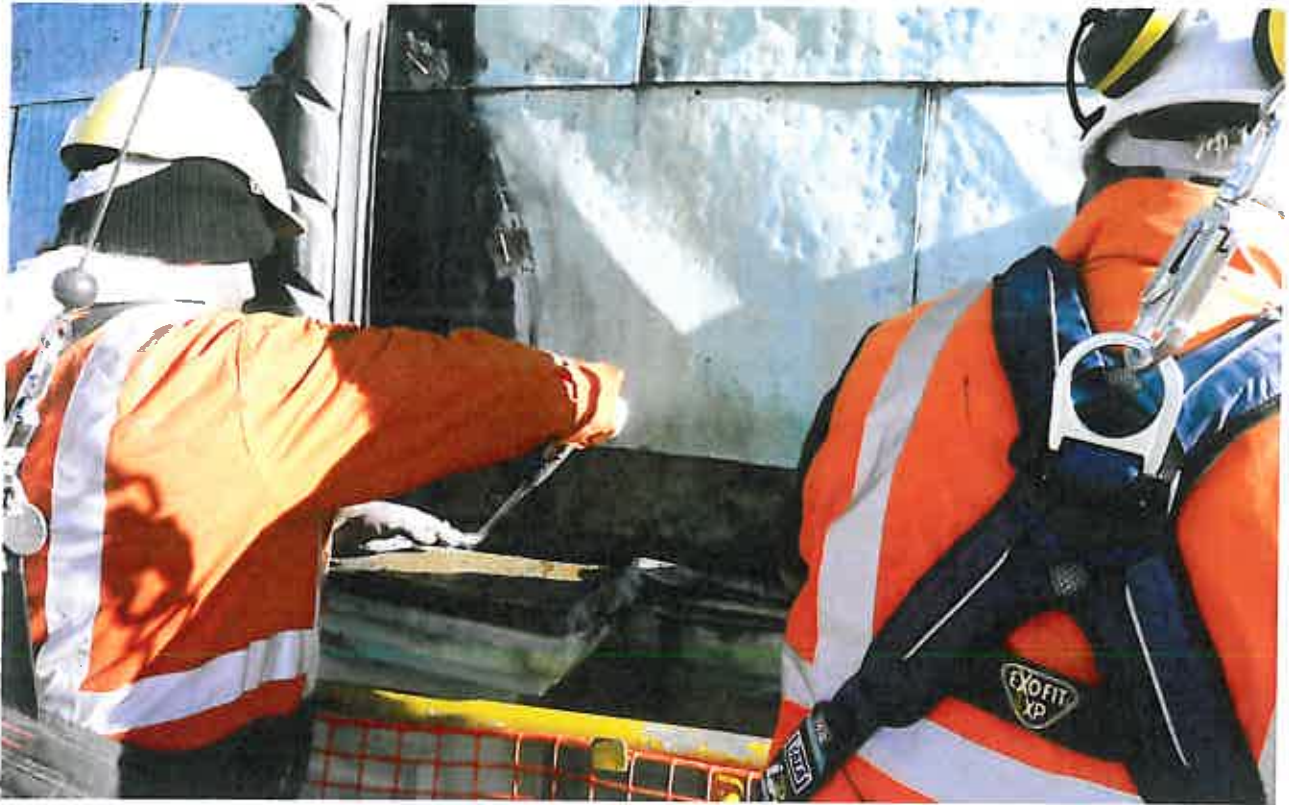
Images: In the team: Duayne Vercoe Crane Driver/Dognan and Murray Flett Site Manager, complete preparations for removing the stonemason's dome. Image courtesy of Goud International Consultants
